CLEANING A STEEL

MINI-MILL

“When You’re Hot,
You’re Hot!”

by Lydia Frenzel, Ph.D.

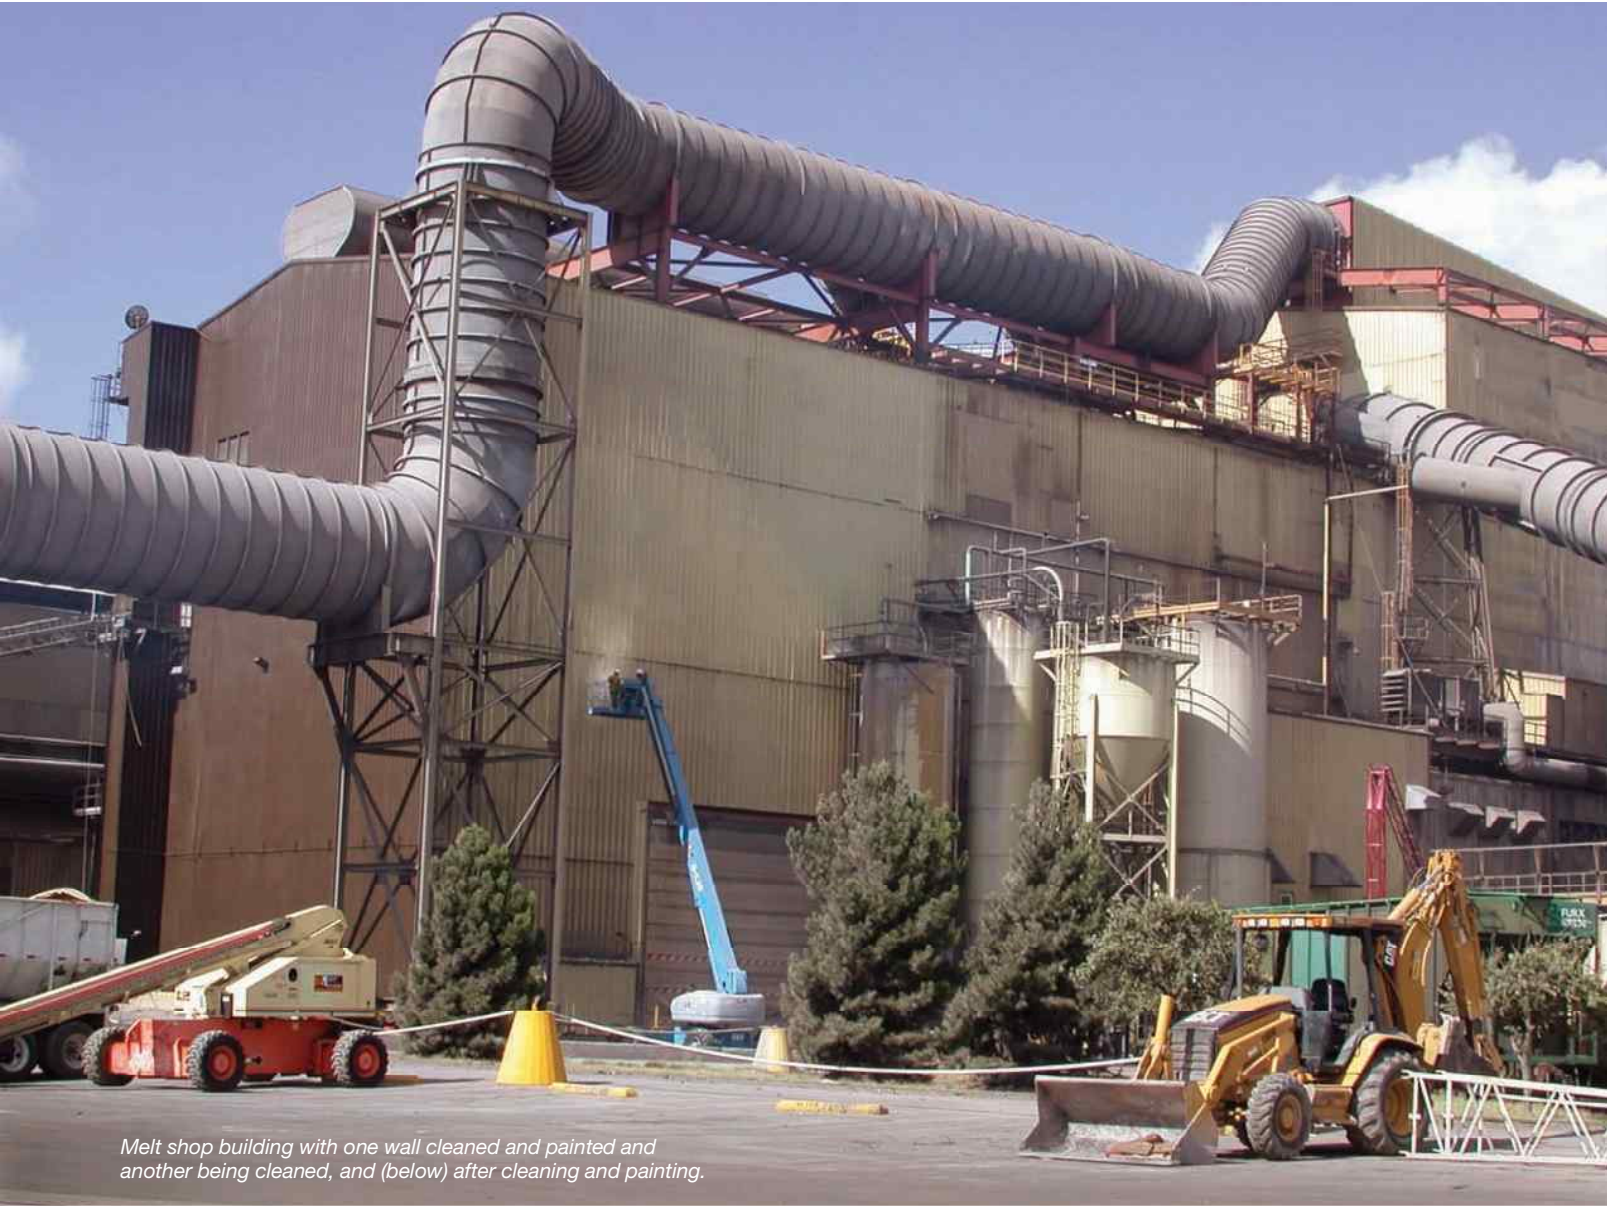
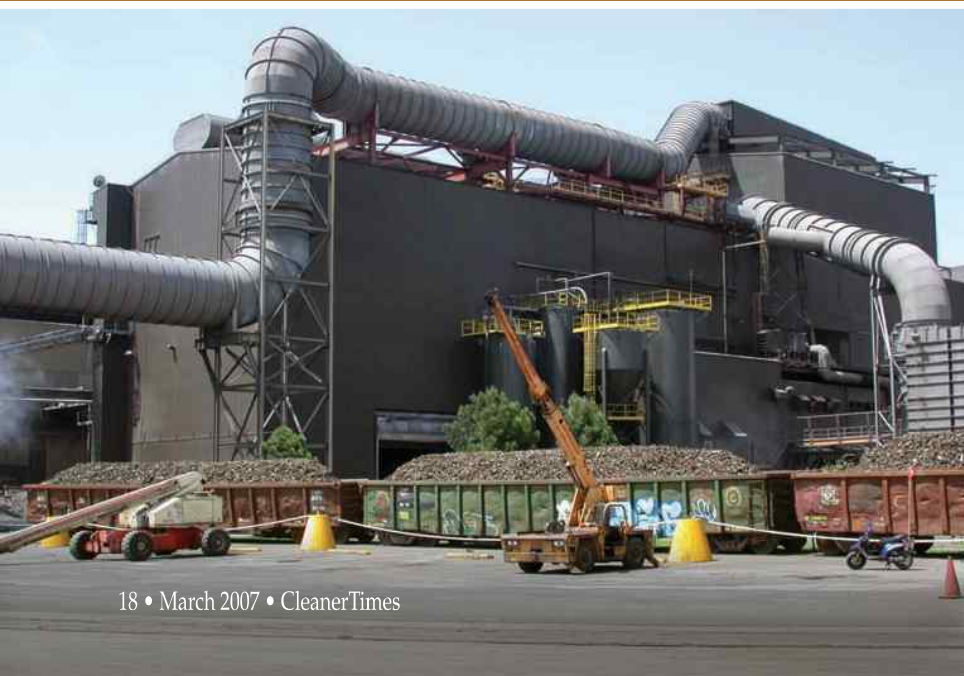
Melt shop building with one wall cleaned and painted and another being cleaned, and (below) after cleaning and painting.

This was metal siding with ribs. The current coating was adhered GalvAlume. This is like an anodized aluminum-zinc coating on steel. It really cuts down on corrosion and is an integral part of the substrate. The challenge was to clean the coating without removing the coating.

SURMAC applied Eldorado Solutions ACL-622 Acid Cleaner and let it set. (www.eldoradochem.com) SURMAC then used 5000 psi with a rotary jet at 12 gpm. The acidity helped to get the old rust off. This cleaning agent really cleaned off the dust and stuck-on debris that had built up over time.

Several commercial paints had been tested over the prior year to see which one would adhere (stick) to the GalvAlume. The original coloration was close to a canary yellow after it was cleaned. Fox Industries (www.foxind.com) FX-509 Rust Inhibitive Coating was very compatible. Fox matched the color—Walnut Brown—of the new construction.

Saturdays and Sundays were painting days. They did the work without one complaint of overspray on cars. The parking lot holds about a thousand cars and is within 400 feet of the building. Cars were moved as necessary. SURMAC had originally thought that they could roll the paint. The ribbed structure excluded that plan. They ended up using airless spray with multi-guns, about four guns on a four gpm delivery system.

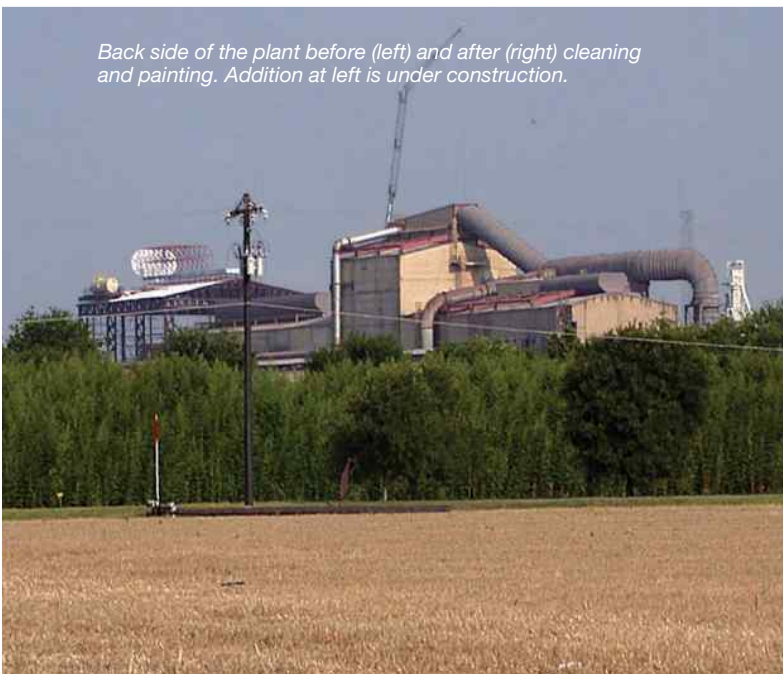
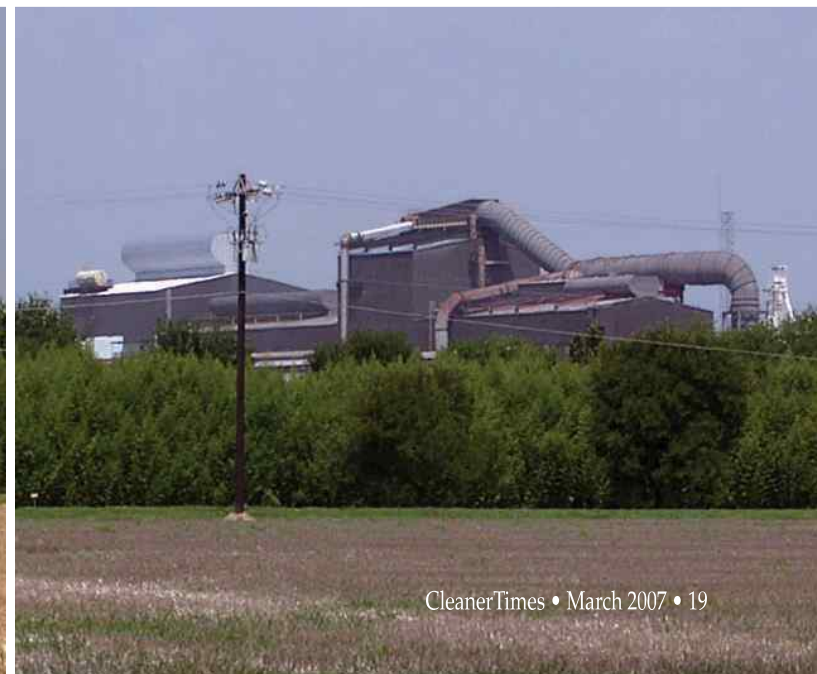
Back side of the plant before (left) and after (right) cleaning and painting. Addition at left is under construction.

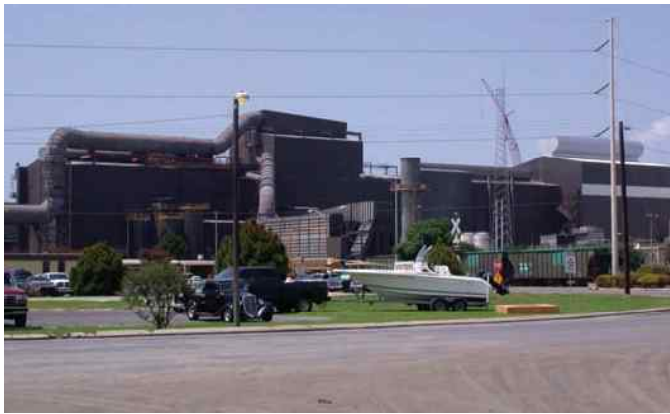
View of the completed project. Approximately 140,000 sq ft of surface was cleaned and painted to match the new addition (at right, with white stripe).

The main building was approximately 12 stories (120 ft) high, 150 ft wide, and about 700–800 ft long. The total square footage was about 140,000 sq ft.
